Case Study airfield repairs

Reconstruction of runways with Plastifloor® in
Siberia at -35°C

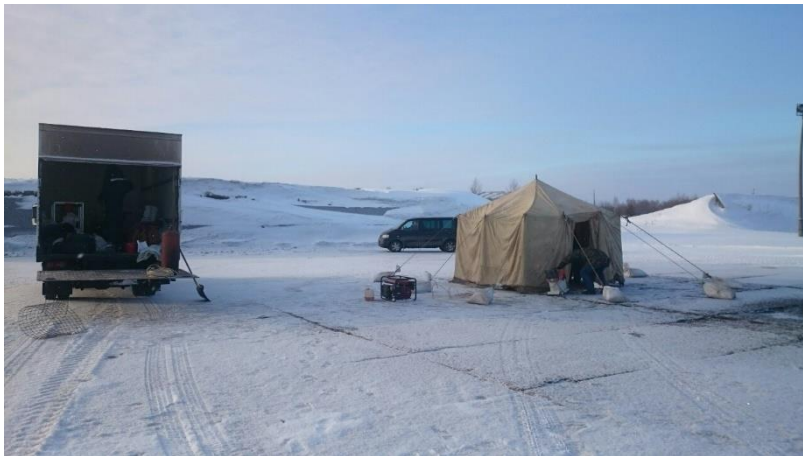
Siberia at -35°C

The pictures show the situation on-site before application of the Plastifloor® mortar system:

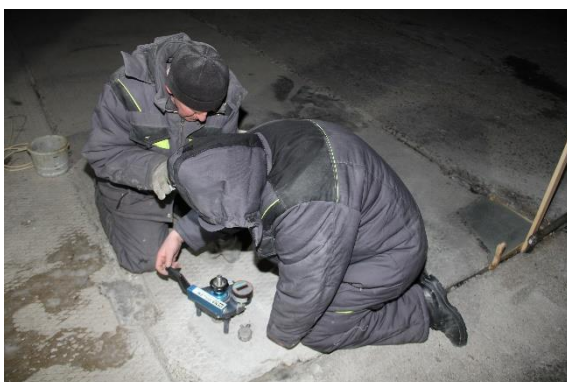
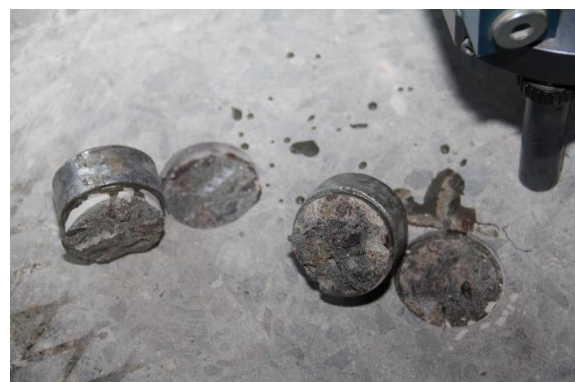
The iced concrete substrate needs to be cleaned, ice and water need to be removed. Proper substrate preparation was necessary with electric hammer and hand grinding some areas to ensure that substrate pores are opened. Adhesive strength needs to be measured.

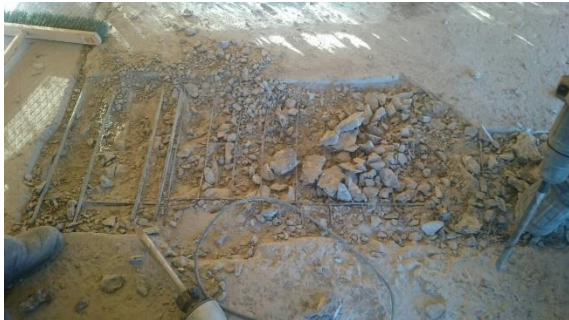
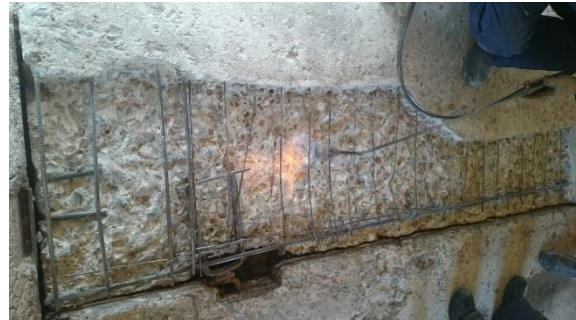
After cleaning and drying the prepared substrate will be primed with the fast curing Plastifloor 118 primer together with Additive B101 and hardener 50 W. It will be applied by brushes and rollers and broadcasted with quartz sand 0,6 -1,2 mm.

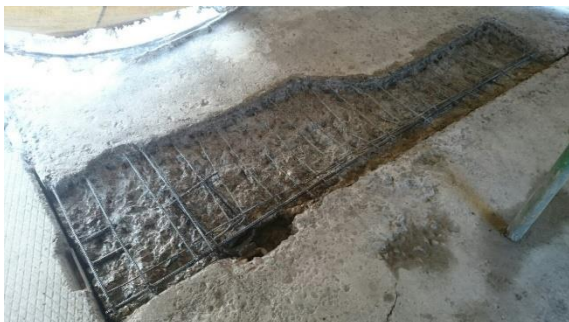
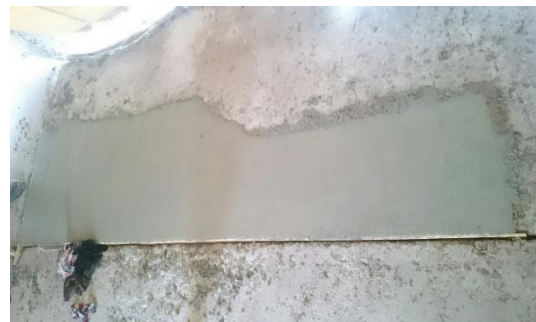
The Plastifloor MMA resins are curing together with the accelerator B 101 and hardener 50 W even at -35°C within 1 h.

Only 2 hours after starting the job this edge of the broken concrete runway was repaired. After 1 h curing time airplanes can start/landing again.
